Case History DETAILED DESIGN & CONSTRUCTION

Geotechnical Services for Stabilization of Fort St. James Landfill

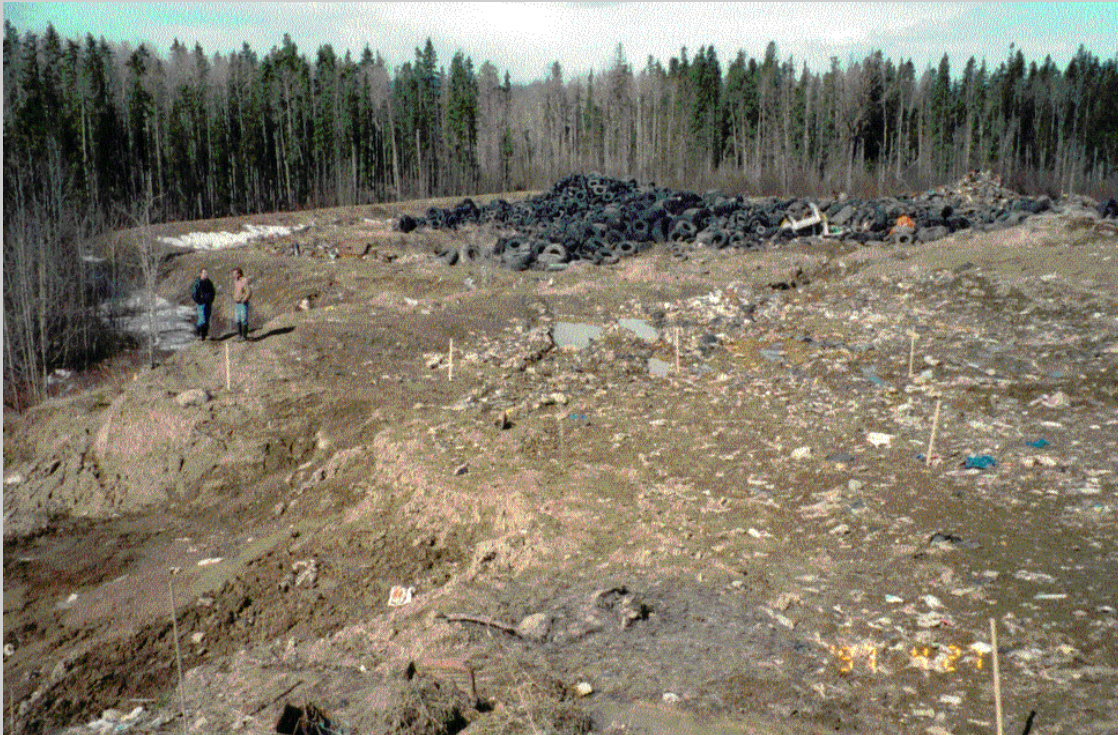
- *Large tension crack noted at Fort St. James Landfill in Fall of 1996.*
- *Failure zone located on steep bank directly above Necosline River.*
- *Preliminary assessment and survey conducted in mid-winter.*
- *Natural slump occurred before site could be stabilized. SHA's provided emergency response. Investigation showed that no refuse was involved.*
- *Slope is now being stabilized by further flattening and refuse pull-back to ensure that slide will not progress.*
