LANDFILL GROUT DESIGN/CONSTRUCTION

Grout Barrier System Design Premier St. Landfill – North Vancouver

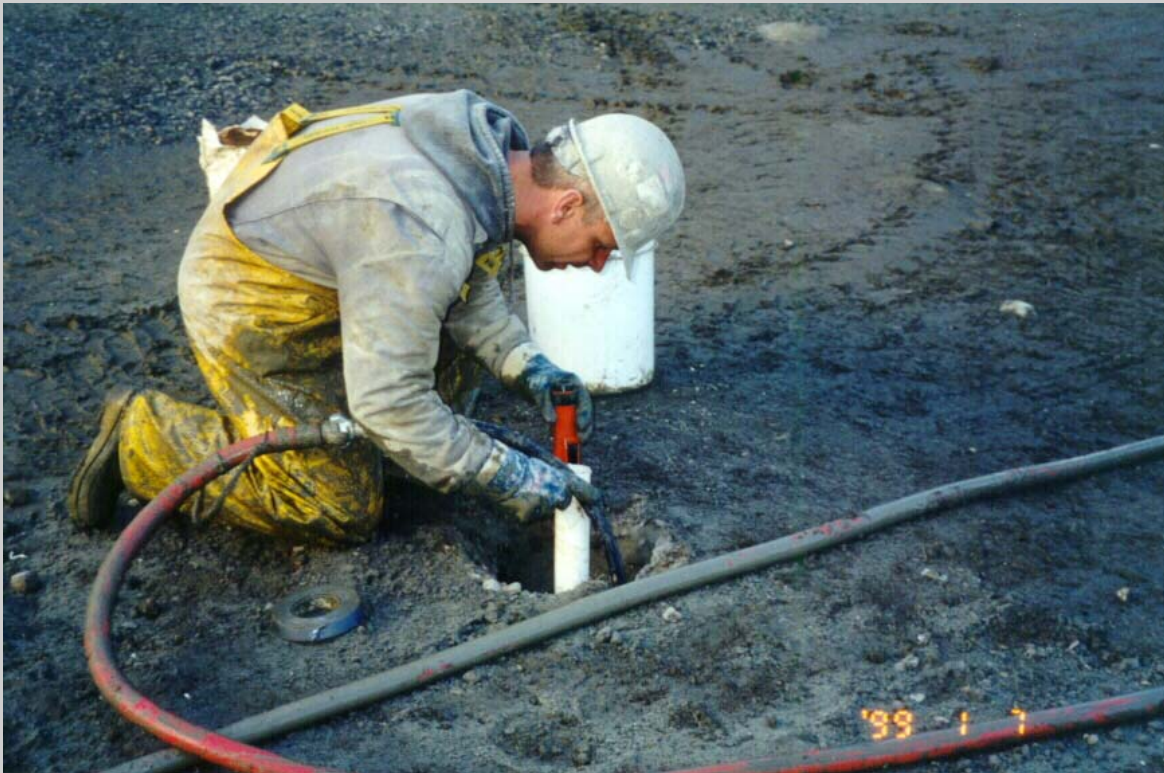
- *SHA was involved in the design of a grout barrier system to prevent leachate from entering Lynn Creek.*
- *The toe berm at the landfill was not effective and so a series of concrete grouted boreholes were placed in order to seal the toe berm from further leachate seepage allowing the leachate to be channeled to the leachate collector.*
