**SPERLING
HANSEN
ASSOCIATES**

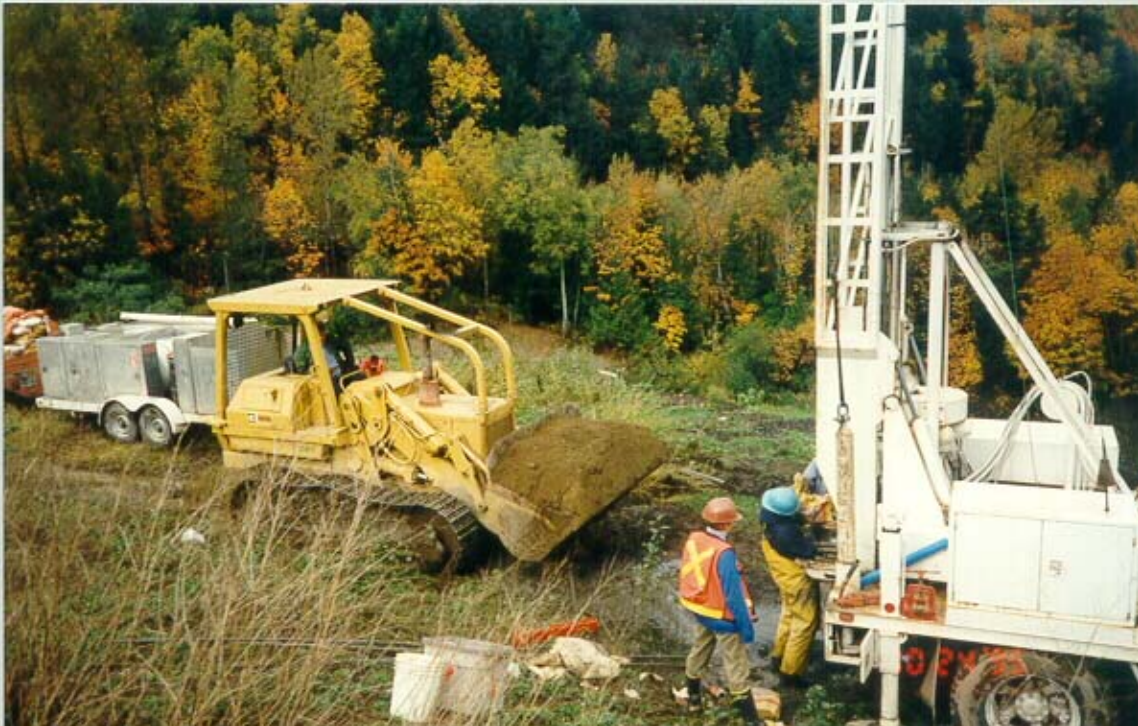
- *MoELP was concerned about 40 m high north face of Hope Landfill that had been constructed with slopes steeper than 2H:1V.*
- *Geotechnical consultants surveyed and identified movement of several cm per year.*
- *SHA installed inclinometers and interpreted survey data.*
- *Data showed that slope is stable. Movement is natural vertical settlement with no down-slope horizontal component.*
